Manhole Inspection Summary

Manhole # S27G__020MH

Location Address: **883 Callender St**

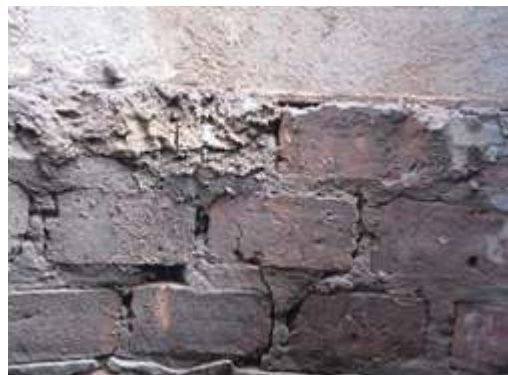
Defect 2

Condition: ☐ Sound ☒ **Cracked** ☐ Root Intrusion ☐ Loose Brick ☐ Deteriorated

Infiltration: ☐ None ☐ Joint ☐ Cracks ☒ **Mortar** ☐ Roots ☐ Wall

cobrel cond cracked, corbel mortar

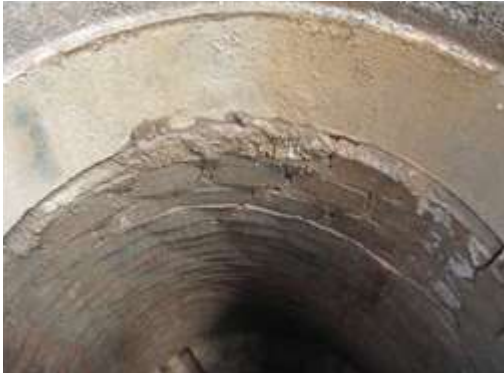
Defect 1

Frame Offset: **0** (in.) Condition: ☐ Sound ☐ Cracked ☒ **Leaks**

Infiltration: ☐ None ☒ **Joint** ☐ Cracks ☐ Mortar ☐ Roots ☒ **Wall**

frame leaks, chimney joint, chimney flow wall

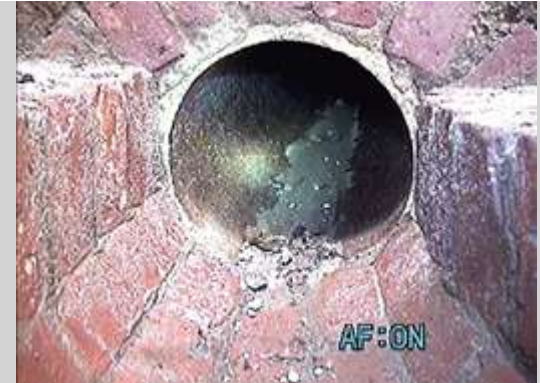
12 O'Clock Outflow

8 in. Circular Gravity Sewer
Pipe Out @ 12 O'Clock

Pipe Height: **8.4** (in.) Rod and Bar (Angled)
Pipe Material: **Clay** ☐ Pipe Lined
Invert Depth: **7.82** (ft.) Flow Characteristics: **None**
Deposits: ☒ None ☐ **Mud** ☐ Sludge ☐ Debris ☐ Grease
Silt Depth: **0** (in.) Deposits Extent:
Infiltration: **None** Pipe Seal Cond: **Sound**

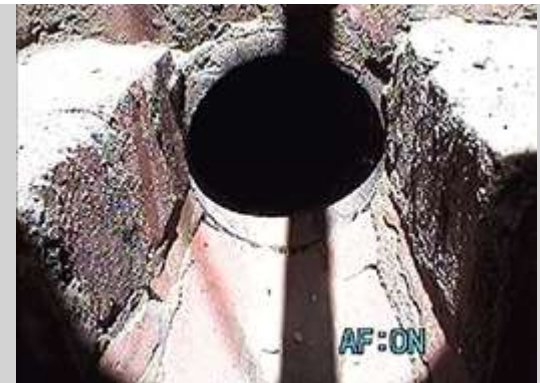
3 O'Clock Inflow

6 in. Circular Gravity Sewer
Pipe In @ 3 O'Clock

Pipe Height: **6** (in.) Rod and Bar (Angled)
Pipe Material: **Clay** ☐ Pipe Lined
Invert Depth: **7.26** (ft.) Flow Characteristics: **None**
Deposits: ☒ None ☐ **Mud** ☐ Sludge ☐ Debris ☐ Grease
Silt Depth: **0** (in.) Deposits Extent:
Infiltration: **None** Pipe Seal Cond: **Sound**

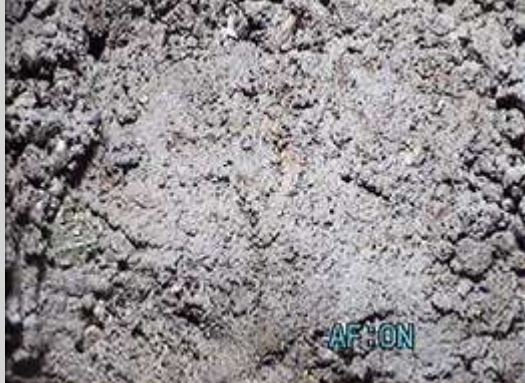
5 O'Clock Inflow

Deposits: ☐ None ☒ **Mud** ☐ Sludge ☐ Debris ☐ Grease

Silt Depth: **6** (in.) Deposits Extent: **Heavy**

Infiltration: **Evidence** Pipe Seal Cond: **Unknown**

Connects To: **Stub connection / abandoned**
